# RECALL ACTION

Recall Action  
Number: P017

## Brake Vacuum Assistance System

Publication No.:	P017v6
Model:	Discovery 3/LR3 2.7L TDV6
Model Year:	2005-2009
VIN Range:	LA000005 – LA513325
Model:	Range Rover Sport 2.7L TDV6
Model Year:	2005-2009
VIN Range:	LS900002 – LS999983 LS100000 – LS215571
Date of Issue:	November 2010

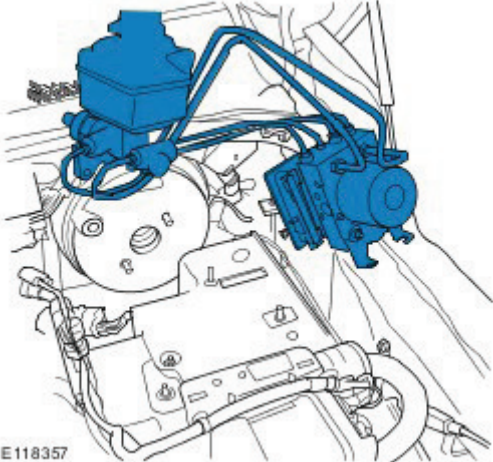
Move Master Cylinder, Brake Pipes and ABS Modulator assembly only a sufficient amount to gain access to master cylinder push rod. Taking care not to twist pipes in their unions (see Fig 18).</p> <p>Displace the master cylinder (see Fig. 18).</p> <ul style="list-style-type: none"> <li>Remove the two nuts.</li> <li>Check for oil deposit on master cylinder push rod.</li> </ul>

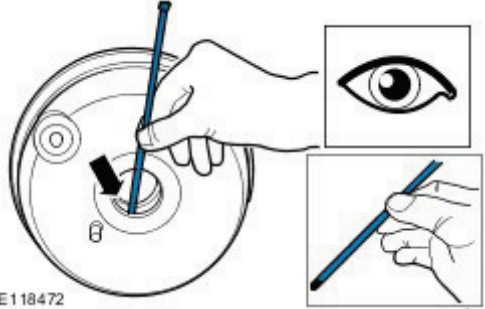
Fig. 19
	<b>All vehicles</b>	
27	<p><b>CAUTION:</b>

<p>E118357</p>
		Fig. 18
26	<p>Check for oil ingress in brake booster (see Fig. 19).</p> <ul style="list-style-type: none"> <li>Using a suitable white cable tie check for oil ingress.</li> <li><b>If oil on the master cylinder push rod, install a new master cylinder (See (GTR), Workshop Procedure, section: 206-06).</b></li> <li><b>If oil is in the brake booster, install a new brake booster (See (GTR), Workshop Procedure, section: 206-07).</b></li> <li><b>If no oil in the brake booster and master cylinder, carry on from step 27.</b></li> </ul>
